Falcon Sat-3

Qualification Model (QM)

Thermal-Vacuum, Vibration Test, and Mass Properties Measurement

Test Report

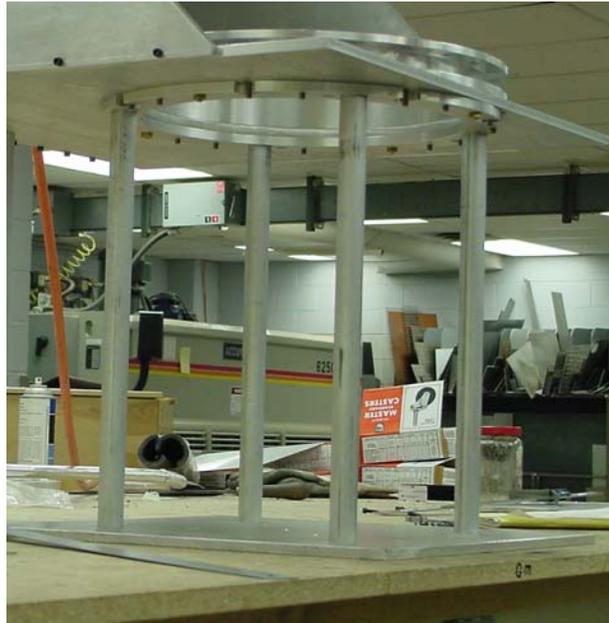
The vertical mounting interface is also used to support the Horizontal interface during spacecraft assembly.

Figure 6 Vertical Stand (Shown Mounted Under Horizontal Stand)

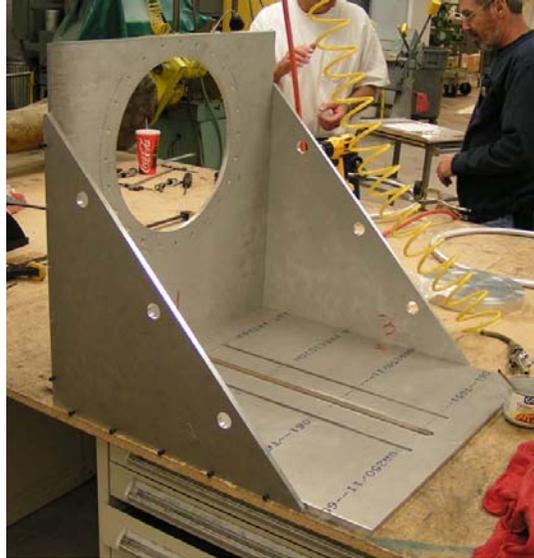
The horizontal mounting bracket allows the spacecraft to be mounted onto the mass properties table to measure the following:

- Moment of Inertia around X from CoG (I_{xx})
- Moment of Inertia around Y from CoG (I_{yy})
- Center of Gravity in the Z axis from SC origin

Figure 7 Horizontal Mounting Interface

The horizontal mounting bracket facilitates the rotation of the QM between horizontal and vertical. The composite must be held at all times when lifted, to prevent any unwanted rotation; and no personnel should stand under a suspended load at any time. The interface is mounted onto the vertical interface for support and to clear the spacecraft boom when assembled. The horizontal mount has an additional leg to support it: this must be assembled before the interface is positioned onto the vertical stand. The satellite is then lowered onto the interface, and eight nuts are assembled onto the studs that are cleared by the vertical stand. Two long (6-10 feet) straps are connected to the highest side holes. The composite is then lifted whilst personnel holds on to the interfaces. When the assembly has been lifted several feet off the ground it is rotated to the horizontal position and then moved over to the Mass Properties table. The interface has slotted mounting holes to allow the satellite to be mounted at its CoG over the rotation axis of the table. When the composite has been mounted and bolted onto the table the vertical support and the additional leg can be removed. Do not remove the lifting straps before the composite is securely bolted on the table.

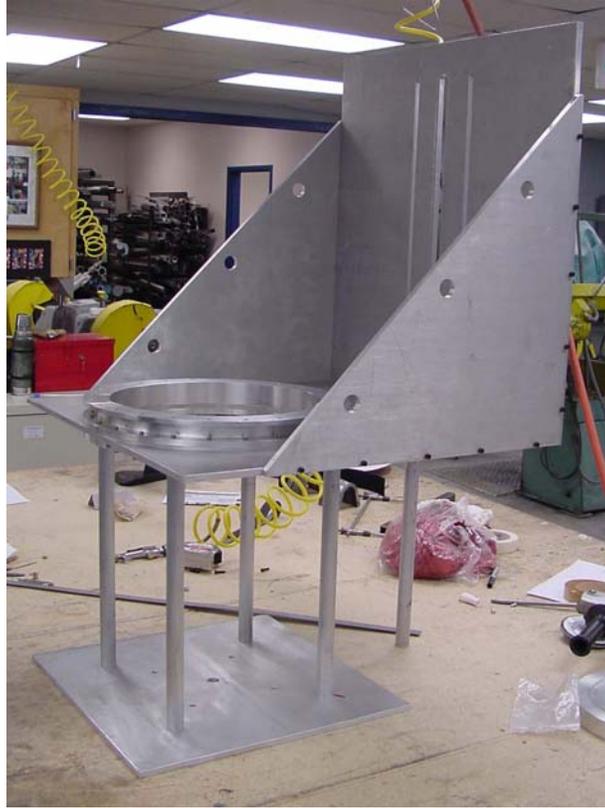
Figure 8 Horizontal Stand on Vertical Stand Ready for Spacecraft to be Integrated to it

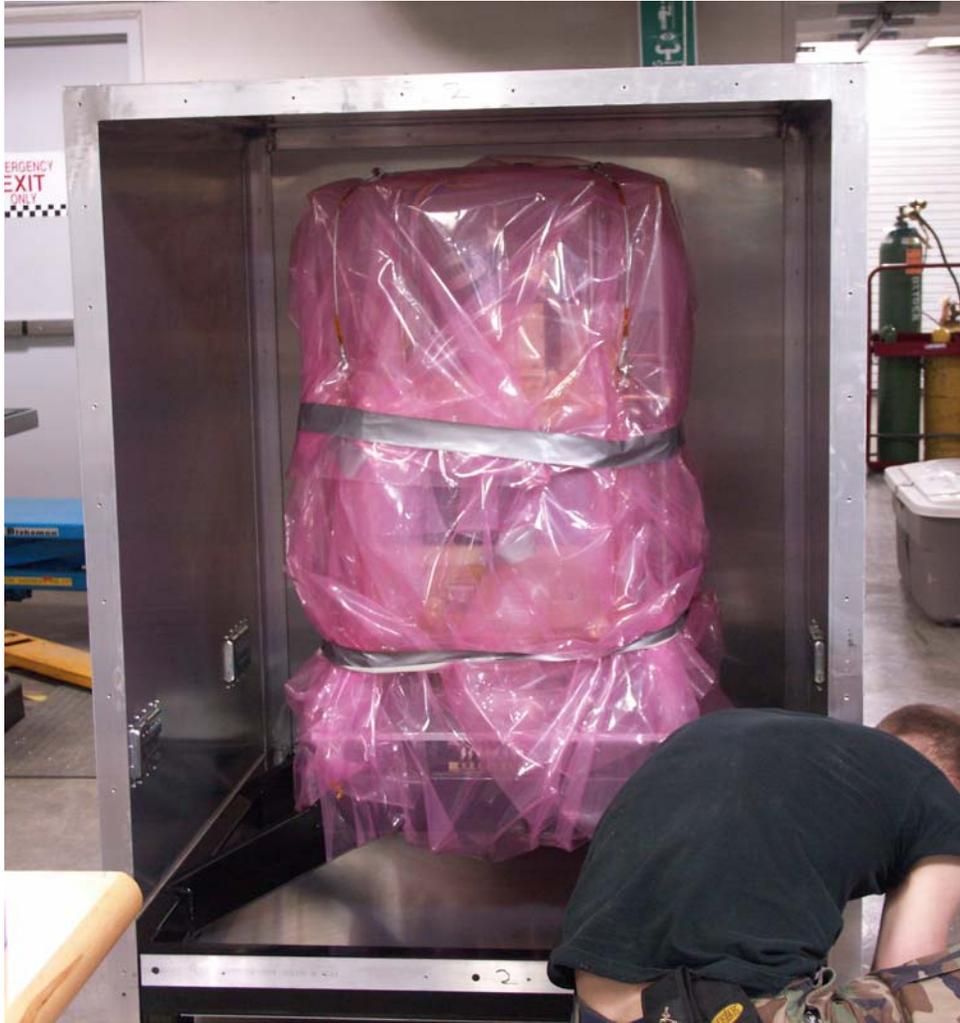
The QM spacecraft was shipped between USAFA and AEF by mounting it directly to the Falcon-Sat 3 shipping container. The shipping container provided for slight damping of the motion encountered by the spacecraft one the trip down to Kirtland AFB. The spacecraft was completely enclosed by the sides of the container to maintain cleanliness and was also enclosed in a plastic electrostatic discharge protected envelop.

Figure 11 Shipping Container with FS-3 QM Mounted in it
